Home Report

85B Comely Bank Avenue
Edinburgh EH4 1EU

Single Survey

Property Address	85B Comely Bank Avenue Edinburgh EH4 1EU
Customer	Alastair Bennett & Lisa Imlach
Prepared by	Graham + Sibbald LLP
Date of Inspection	03/01/2025

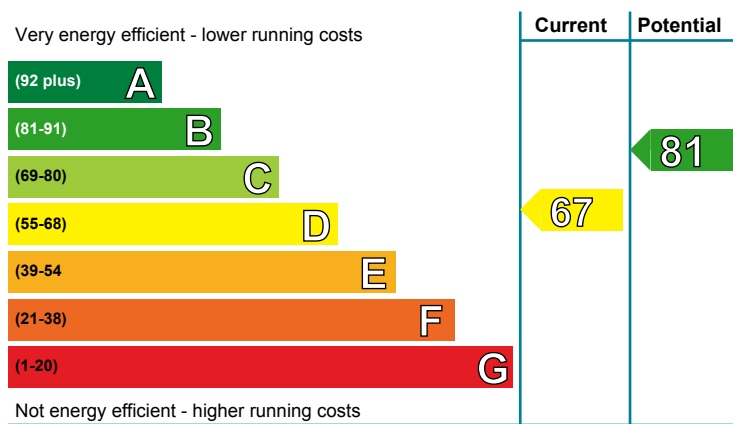
Energy Efficiency Rating

Your current rating is **band D (67)**. The average rating for EPCs in Scotland is **band D (61)**.
