108 Silverknowes Road
Edinburgh
EH4 5LD
19/04/2024

Single Survey

survey report on:

Property address	108 Silverknowes Road, Silverknowes, Edinburgh, EH4 5LD
-------------------------	--

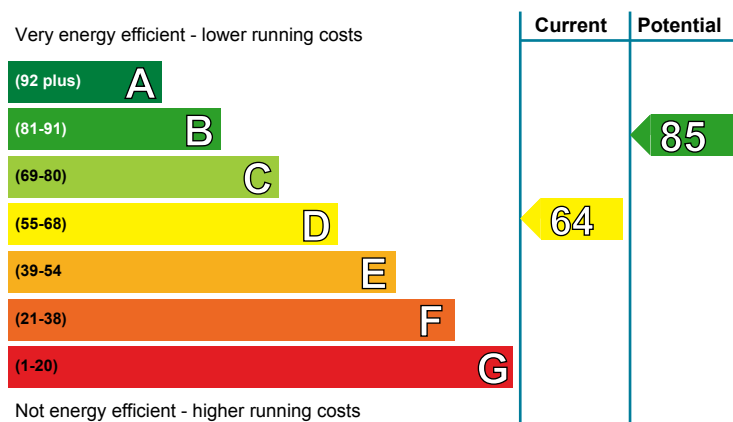
Energy Efficiency Rating

This graph shows the current efficiency of your home, taking into account both energy efficiency and fuel costs. The higher this rating, the lower your fuel bills are likely to be.

Your current rating is **band D (64)**. The average rating for EPCs in Scotland is **band D (61)**.

The potential rating shows the effect of undertaking all of the improvement measures listed within your recommendations report.

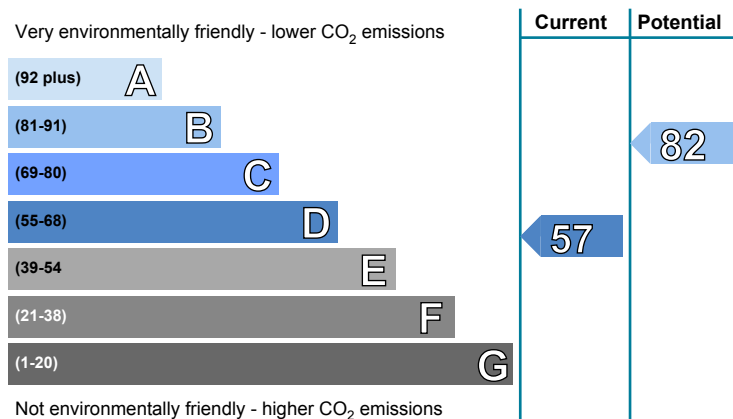
Environmental Impact (CO₂) Rating

This graph shows the effect of your home on the environment in terms of carbon dioxide (CO₂) emissions. The higher the rating, the less impact it has on the environment.
