espc:home report

Home Report Index

Single Survey

Property address	8G Canon Street, Broughton, EDINBURGH, EH3 5HE
-------------------------	---

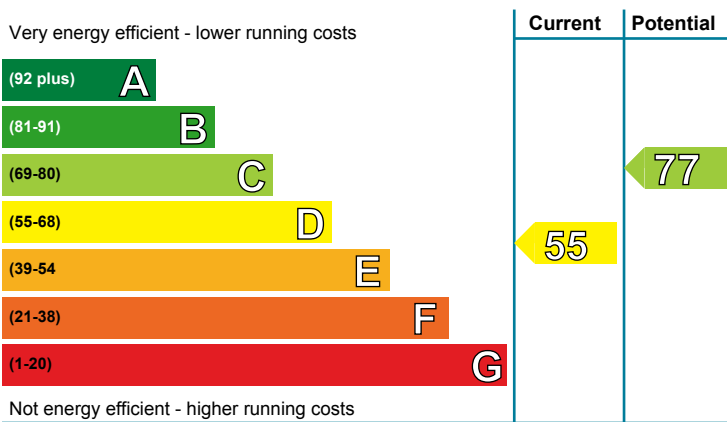
Energy Efficiency Rating

This graph shows the current efficiency of your home, taking into account both energy efficiency and fuel costs. The higher this rating, the lower your fuel bills are likely to be.

Your current rating is **band D (55)**. The average rating for EPCs in Scotland is **band D (61)**.

The potential rating shows the effect of undertaking all of the improvement measures listed within your recommendations report.

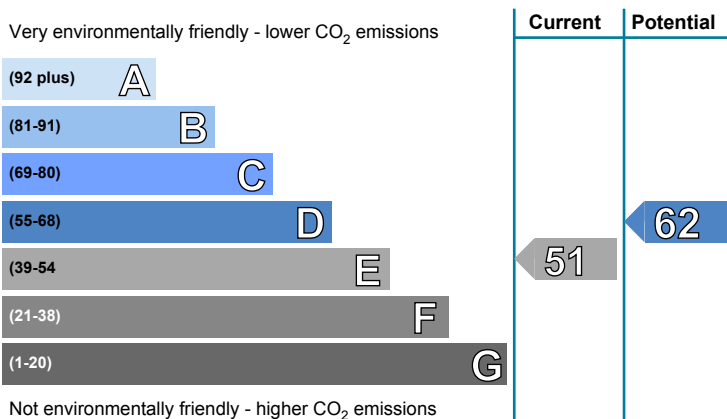
Environmental Impact (CO₂) Rating

This graph shows the effect of your home on the environment in terms of carbon dioxide (CO₂) emissions. The higher the rating, the less impact it has on the environment.

The potential rating shows the effect of undertaking all of the improvement measures listed within your recommendations report.

The average Scottish household produces about 6 tonnes of carbon dioxide every year. Based on this assessment, heating and lighting this home currently produces approximately 3.5 tonnes of carbon dioxide every year. Adopting recommendations in this report can reduce emissions and protect the environment. If you were to install all of these recommendations this could reduce emissions by 0.8 tonnes per year. You could reduce emissions even more by switching to renewable energy sources.
