Home Report

Single Survey

Property address	62 Ravensheugh Road Musselburgh EH21 7SY
-------------------------	--

Prepared by	Shepherd Chartered Surveyors
--------------------	------------------------------

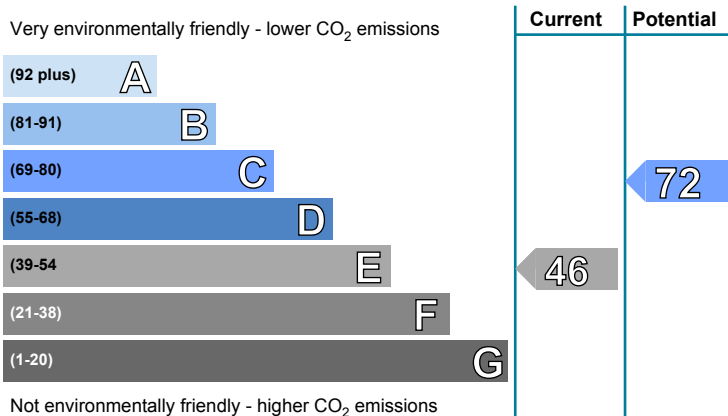
Environmental Impact (CO₂) Rating

This graph shows the effect of your home on the environment in terms of carbon dioxide (CO₂) emissions. The higher the rating, the less impact it has on the environment.
