espc:home report

8 Granton Road, Trinity
Edinburgh
EH5 3QH
17/04/2024

Single Survey

Property address	8 Granton Road, Trinity, Edinburgh, EH5 3QH
-------------------------	--

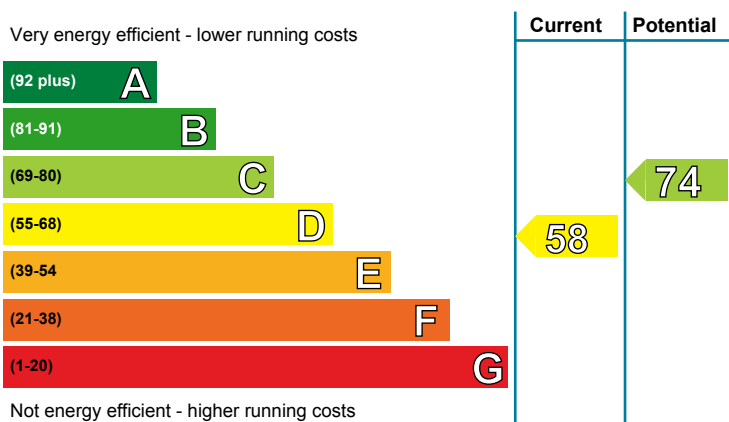
Energy Efficiency Rating

This graph shows the current efficiency of your home, taking into account both energy efficiency and fuel costs. The higher this rating, the lower your fuel bills are likely to be.

Your current rating is **band D (58)**. The average rating for EPCs in Scotland is **band D (61)**.

The potential rating shows the effect of undertaking all of the improvement measures listed within your recommendations report.

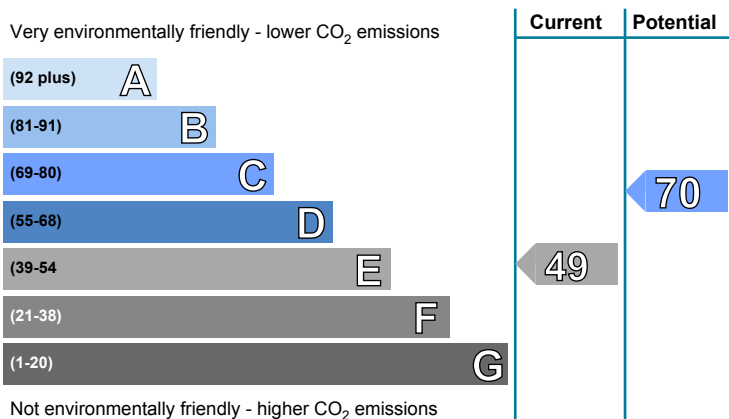
Environmental Impact (CO₂) Rating

This graph shows the effect of your home on the environment in terms of carbon dioxide (CO₂) emissions. The higher the rating, the less impact it has on the environment.
