HOME
report

SINGLE SURVEY
ENERGY REPORT
PROPERTY QUESTIONNAIRE
VALUATION REPORT

Property Address	61 Hope Lane Edinburgh EH15 3AW
Customer	Julie Hutchison
Date of Inspection	26/02/2024
Prepared by	John McCarron Harvey Donaldson & Gibson Chartered Surveyors

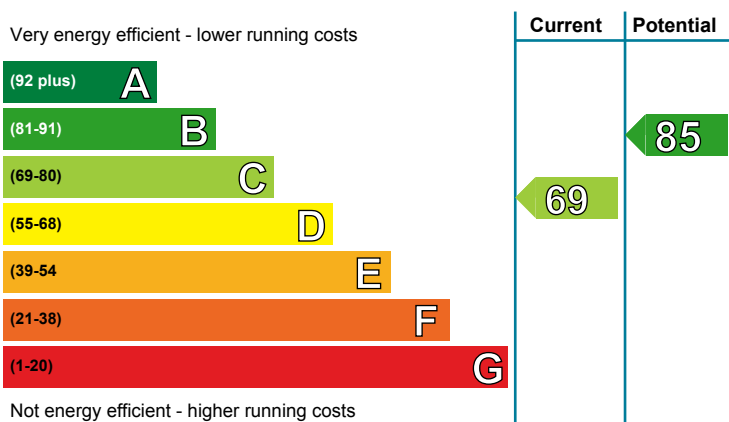
Energy Efficiency Rating

This graph shows the current efficiency of your home, taking into account both energy efficiency and fuel costs. The higher this rating, the lower your fuel bills are likely to be.

Your current rating is **band C (69)**. The average rating for EPCs in Scotland is **band D (61)**.

The potential rating shows the effect of undertaking all of the improvement measures listed within your recommendations report.

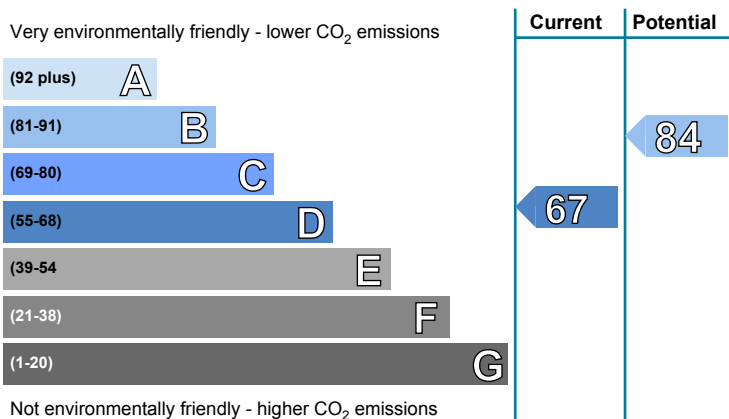
Environmental Impact (CO₂) Rating

This graph shows the effect of your home on the environment in terms of carbon dioxide (CO₂) emissions. The higher the rating, the less impact it has on the environment.
