espc:home report

115 Captains Road
Edinburgh
EH17 8DT
19/04/2024

Single Survey

Property address	115 Captain's Road, Gracemount, Edinburgh, EH17 8DT
-------------------------	--

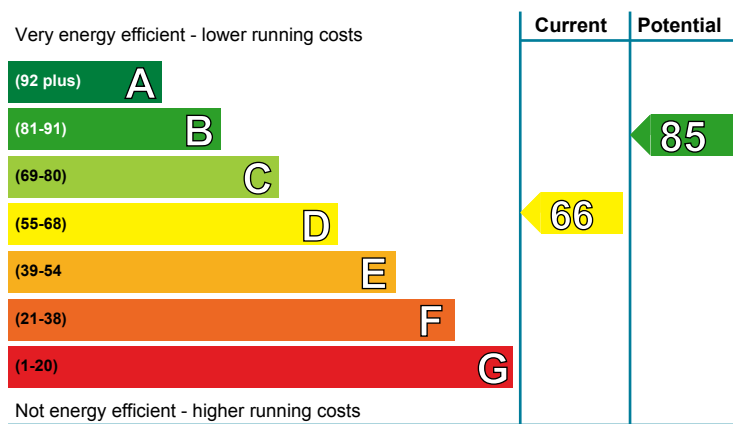
Energy Efficiency Rating

This graph shows the current efficiency of your home, taking into account both energy efficiency and fuel costs. The higher this rating, the lower your fuel bills are likely to be.

Your current rating is **band D (66)**. The average rating for EPCs in Scotland is **band D (61)**.

The potential rating shows the effect of undertaking all of the improvement measures listed within your recommendations report.
